# Uniform Mitigation Verification Inspection Form

| Inspection Date: 6-24-2025 | | |
| Address: 104 Karde Lane | | Home Phone: |

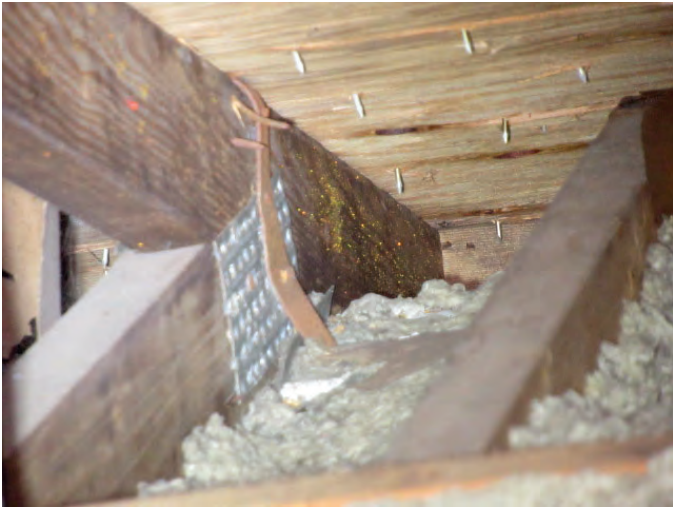
- ☒ A. SWR (also called Sealed Roof Deck) Self-adhering polymer modified-bitumen roofing underlayment applied directly to the sheathing or foam adhesive SWR barrier (not foamed-on insulation) applied as a supplemental means to protect the dwelling from water intrusion in the event of roof covering loss.
- ☐ B. No SWR.
- ☐ C. Unknown or undetermined.
