# Uniform Mitigation Verification Inspection Form

| Inspection Date: 6-24-2025 | | |
| Address: 105 Karde Lane | | Home Phone: |

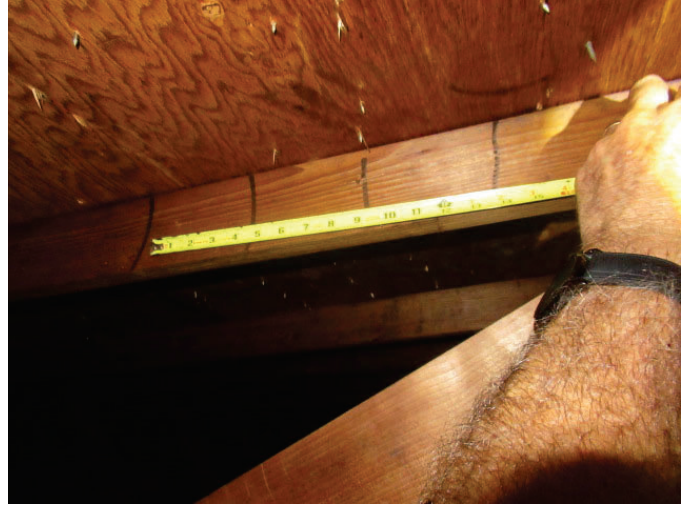
- ☒ A. SWR (also called Sealed Roof Deck) Self-adhering polymer modified-bitumen roofing underlayment applied directly to the sheathing or foam adhesive SWR barrier (not foamed-on insulation) applied as a supplemental means to protect the dwelling from water intrusion in the event of roof covering loss.
- ☐ B. No SWR.
- ☐ C. Unknown or undetermined.
