# Uniform Mitigation Verification Inspection Form

| Address: 110 Gornto Lake Rd. | | Home Phone: |
| City: Brandon | Zip: 33510 | Work Phone: |

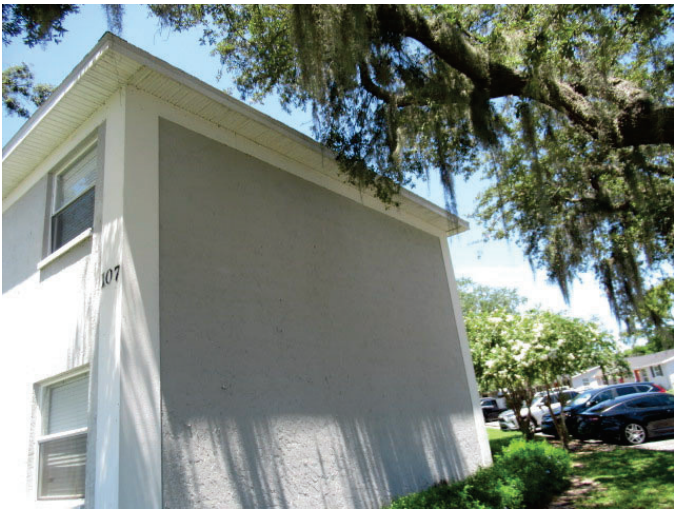
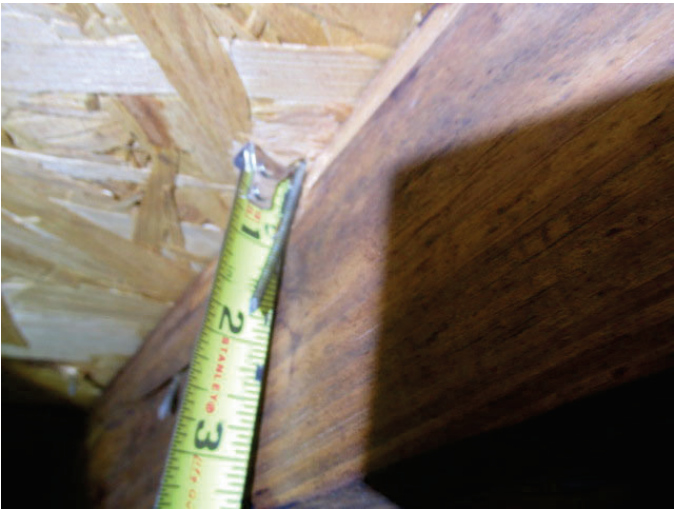
- ☒ A. SWR (also called Sealed Roof Deck) Self-adhering polymer modified-bitumen roofing underlayment applied directly to the sheathing or foam adhesive SWR barrier (not foamed-on insulation) applied as a supplemental means to protect the dwelling from water intrusion in the event of roof covering loss.
- ☐ B. No SWR.
- ☐ C. Unknown or undetermined.
