# Uniform Mitigation Verification Inspection Form

| Inspection Date: 6-24-2025 | | |
| Address: 102 Karde Lane | | Home Phone: |

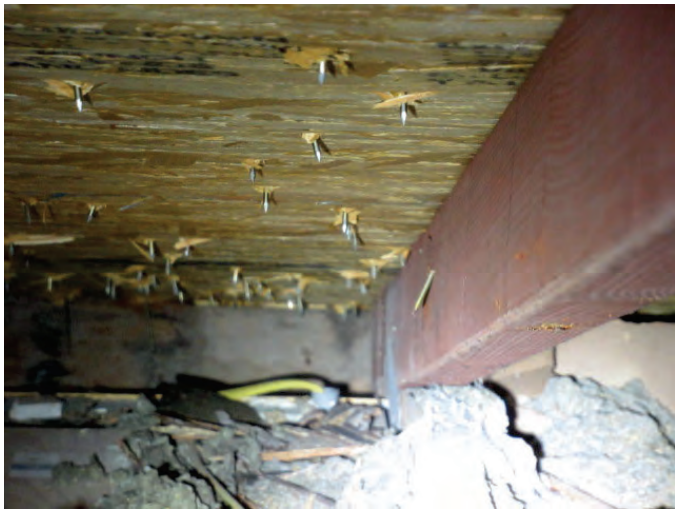
- ☒ A. SWR (also called Sealed Roof Deck) Self-adhering polymer modified-bitumen roofing underlayment applied directly to the sheathing or foam adhesive SWR barrier (not foamed-on insulation) applied as a supplemental means to protect the dwelling from water intrusion in the event of roof covering loss.
- ☐ B. No SWR.
- ☐ C. Unknown or undetermined.
