# Uniform Mitigation Verification Inspection Form

| Inspection Date: 6-24-2025 | | |
| Address: 110 Karde Lane | | Home Phone: |

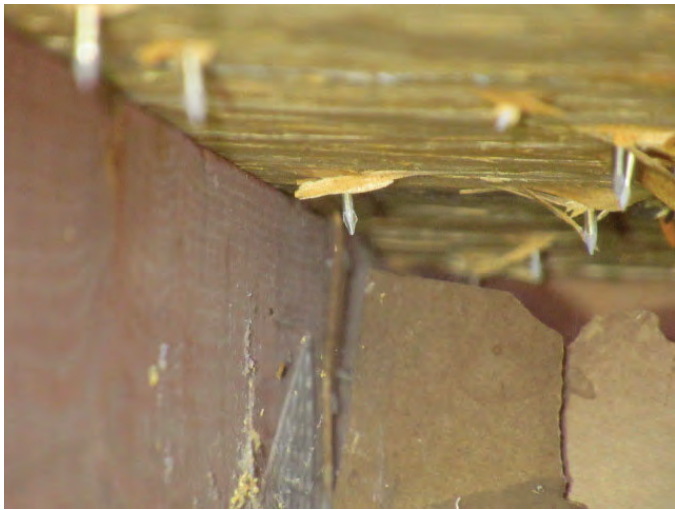
- ☒ A. SWR (also called Sealed Roof Deck) Self-adhering polymer modified-bitumen roofing underlayment applied directly to the sheathing or foam adhesive SWR barrier (not foamed-on insulation) applied as a supplemental means to protect the dwelling from water intrusion in the event of roof covering loss.
- ☐ B. No SWR.
- ☐ C. Unknown or undetermined.
